# THE DECI REPORT - JANUARY 2002

## ACOUSTIC EMISSION TESTING OF STRUCTURES EXHIBITING HIGH LEVEL VIBRATION AND AIRBORNE NOISE

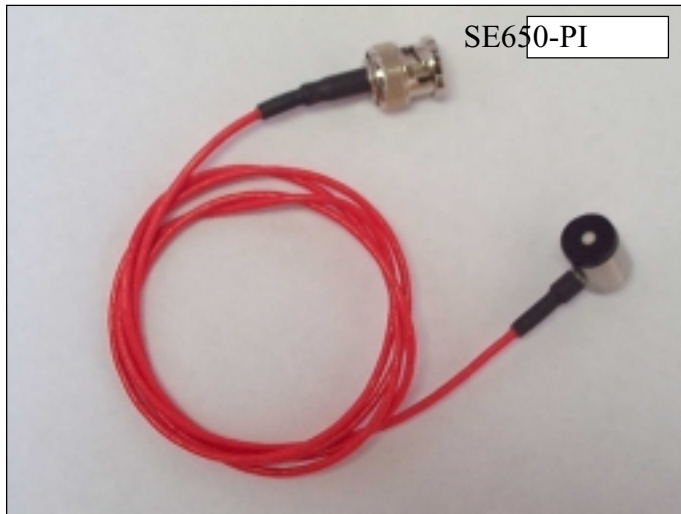
the following reason. Out-of-plane (OP) high frequency airborne noise incident on a plate produces a low frequency flexure wave component that can be filtered out with modal ratio filtering. This same airborne signal hits the transducer with poor acoustic isolation between the active element and the case, producing a high HF/LF ratio and therefore can be interpreted as a signal due to crack growth. The solution to this problem was to replace the SE9125-MI transducer with the SE650-PI transducer

shown in the photograph. This sensor has

a small aperture (0.125 in. dia.) , higher frequency response, is not mass loaded, and has 20dB of acoustic isolation between the active element and case of the transducer. The diameter of the transducer is 0.500 in. and is provided with an integral low noise cable and integral 20dB preamplifier. We believe it to be the smallest integral preamplifier AE transducer in the world.

1. Do not use AE transducers where the active element is mass loaded.
2. Use an AE transducer with good acoustic isolation between active element and case.
3. Use a small aperture transducer to better resolve plate wave frequency components.
4. Utilize at least 5 pole filters in the instrumentation.
